PERFORMANCE EVALUATION OF EXISTING BUILDINGS IN THE AUGUST 24, 2016 CENTRAL ITALY EARTHQUAKE

MARIA HELENA PAIXÃO COSTA

Dissertação submetida para satisfação parcial dos requisitos do grau de
MESTRE EM ENGENHARIA CIVIL — ESPECIALIZAÇÃO EM ESTRUTURAS

JUNHO DE 2017

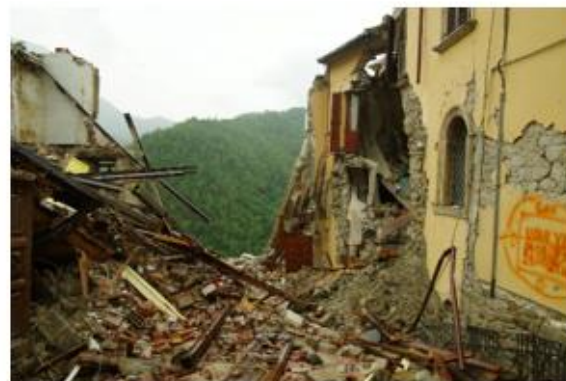
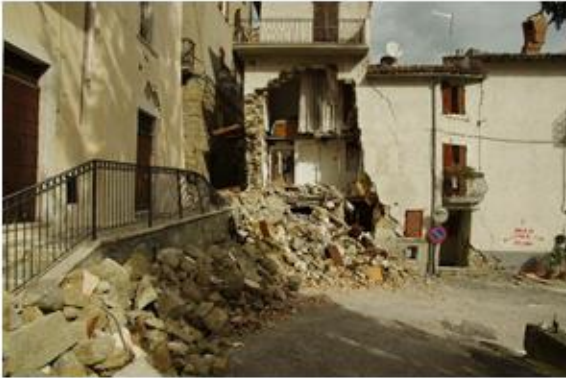
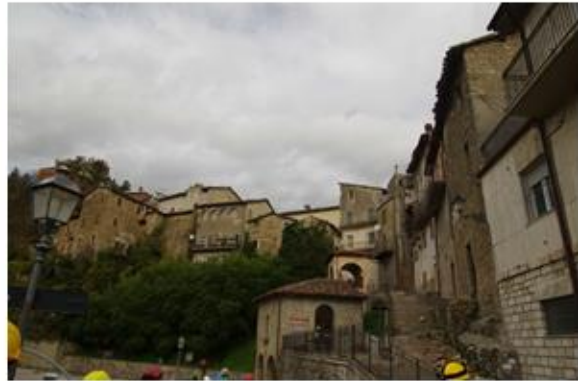
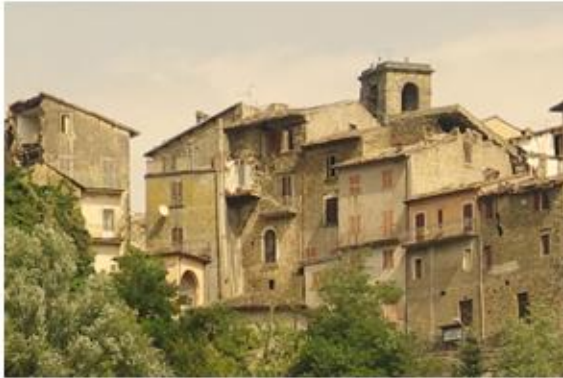
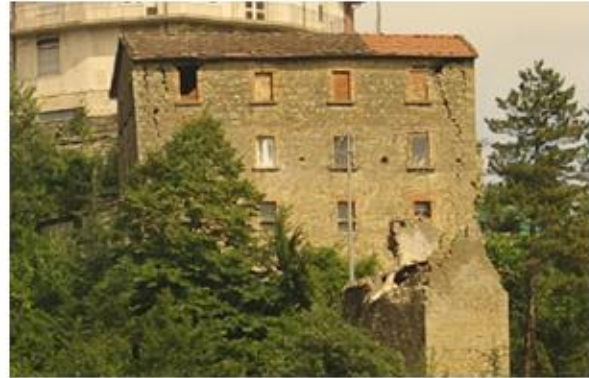
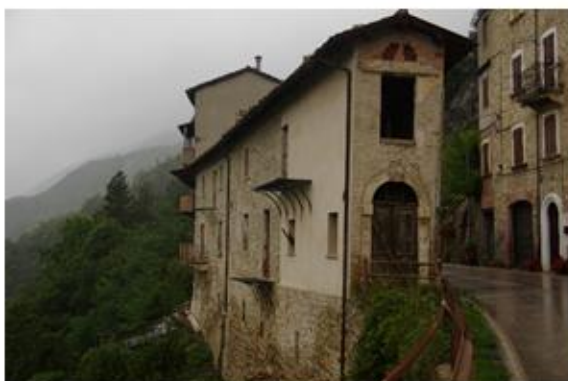
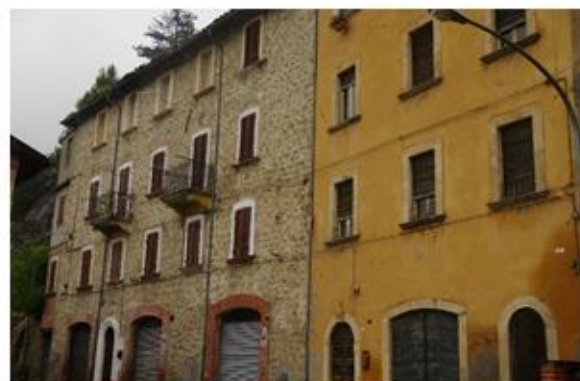
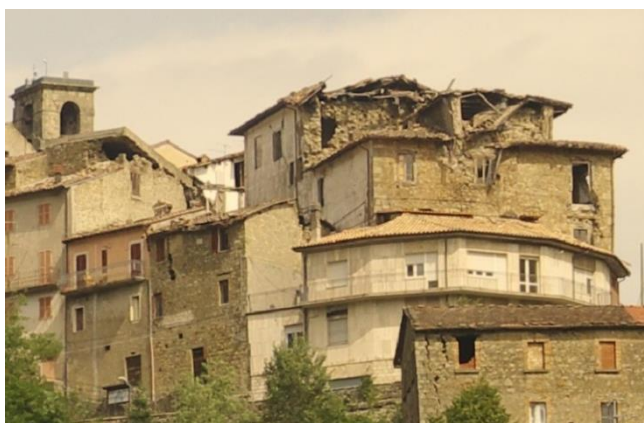
Figure 4.12-Images took from Arquata del Tronto, representative of the area in terms of damage

A possible division of the village according to its level of damage is reported in the figure 4.13. The most injured area, on top of the ridge, is classified as D4-D5 as some buildings fully or partially collapse. However, there were also good seismic exemplars located in the same area classified as D2. The level of damage diminished going in the east direction from D4-D5 to D2-D3, where the buildings P8 are located. Moving away from the edge in both east (pictures P11 and P12) and north direction (Borgo), the level of damage decreases from D3 to D3-D2 and D1-D2.

Image	Damage level	Damage description
P1	D4	Partial collapse of a masonry building
P2	D2	Non-structural damage including detachment of the plaster and incipient out of plane-vertical crack along the intersection
P3	D2	Severe non-structural damage in pier panels to a masonry building
P4	D5	Full collapse of masonry buildings
P5	D5	Full collapse of a masonry building with RC roof
P6		Collapse of a retaining wall
P7	D4	Out of plane mechanism of the front façade involving two floors
P8	D3	Panoramic view, masonry buildings with significant structural damage
P9	D5	Panoramic view, masonry buildings with significant structural damage
P10	D3	Severe cracks along the intersections that may trigger out of plane mechanisms
P11	D1	Minor non-structural damage
P12	D1	Minor non-structural damage
P13	D4	Partial collapse of a masonry building

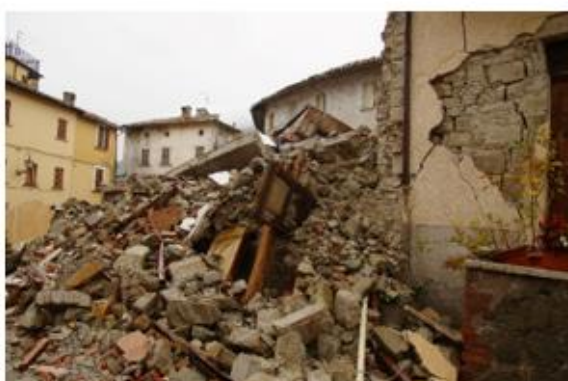
P5

In case of picture P5, the structure exhibited a heavy concrete roof that led to its collapse. The adjacent building (picture P3) behaved completely different only suffering in plane shear failure with detachment of plaster in the pier panels. Cases of total and partial collapse (pictures P1, P4, P7 and P13) occurred but also many masonry buildings behaved well during the event (pictures P2, P3, P11 and P12). Cases of failure of retaining walls were also reported (picture P6) along the road accessing Arquata.

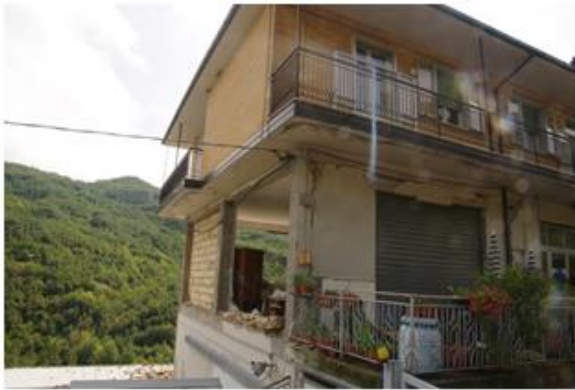
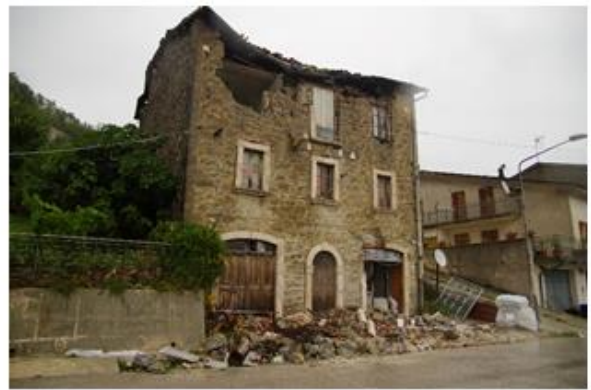
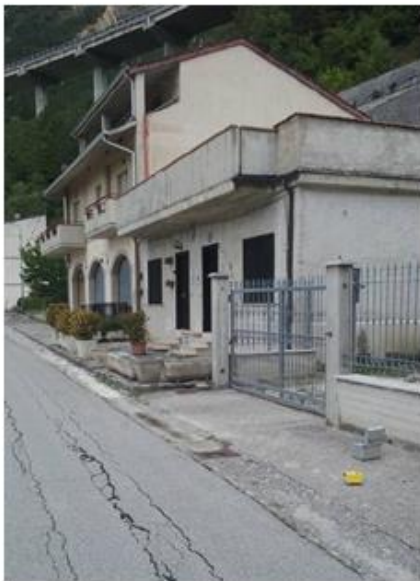
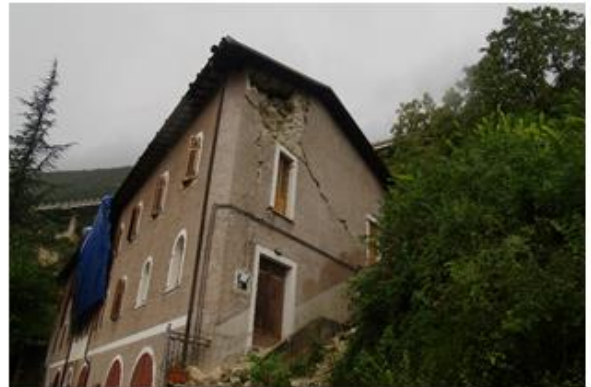
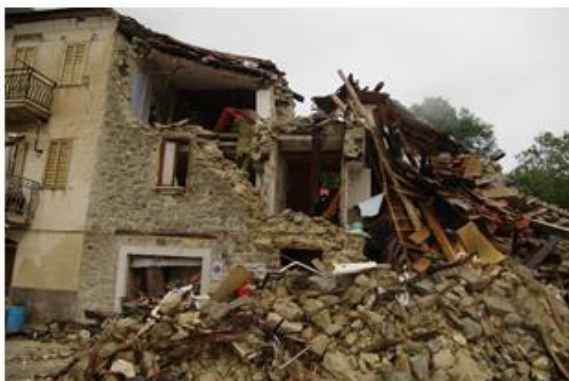
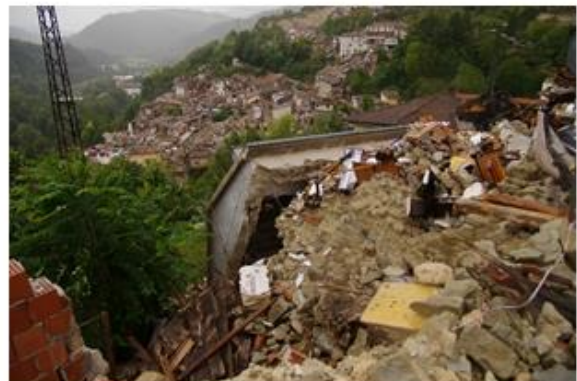
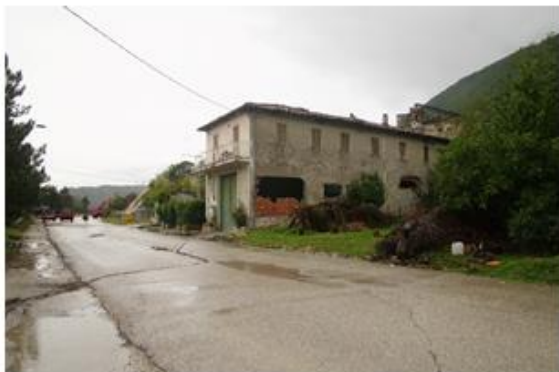
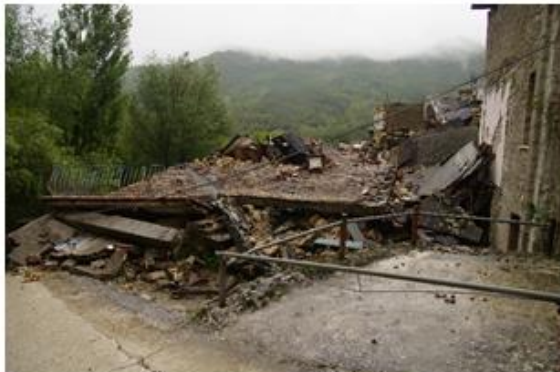
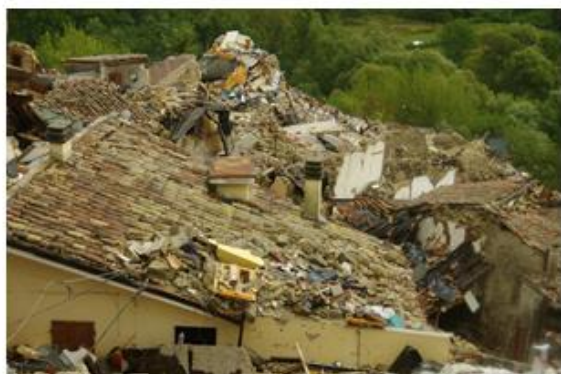
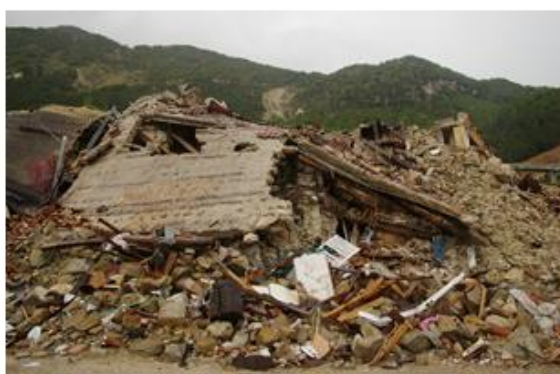
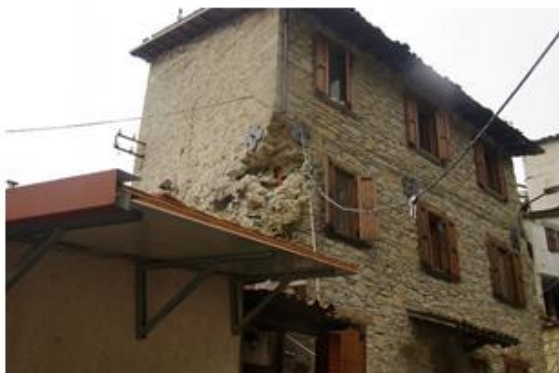
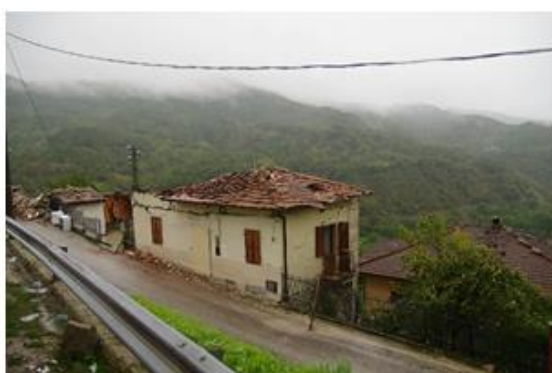
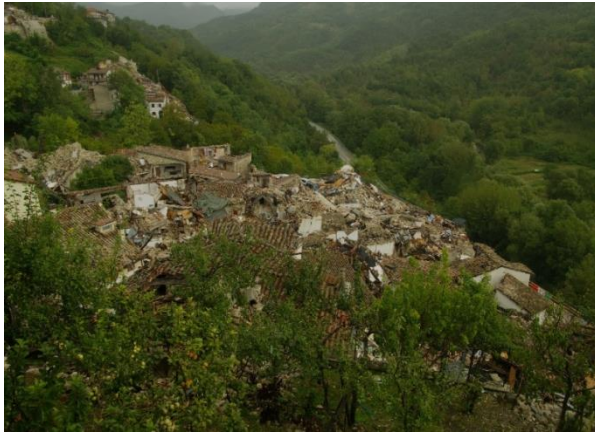
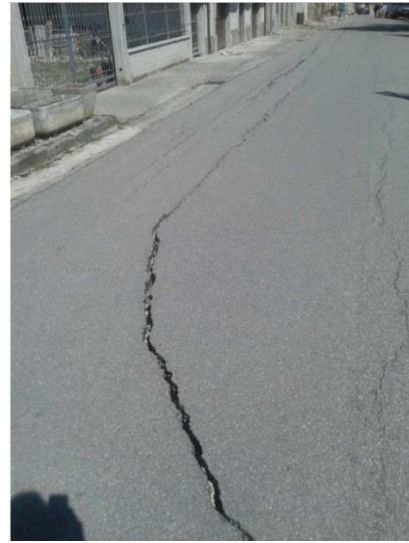
Figure 4.15- Images took from Pescara del Tronto, representative of the area in terms of damage

Picture P11 represents the only retrofitted building found in the village of Pescara and it behaved well under the seismic action. In picture P8, it is well visible the different behaviours of two adjacent buildings: one is the building P11 that only experienced a detachment of material in the corner zone, while its adjacent completely collapsed. Retrofitting measures in the first structure may have saved lives. The most damaged area was the southern part of Pescara del Tronto, with full collapse or partial collapse of the buildings totality (picture P9 and P13). Along the road, the failures seemed slightly lower (picture P3 and P7) although there were also cases of partial collapse (picture P5 and P6). Away from the main agglomerate it can be detected isolated reinforced concrete buildings along the road, which suffered major damage (picture P1): besides the evident out of plane of the infills, the building suffered severe damage in the beam-column joint in especially one column.

In order to make a damage zonation map figure 4.17, the damage patterns were analysed. The first possible conclusion is that the minimum level attributed is D3, excepting two buildings categorized as D2 (figure P3 and P7), demonstrating the high level of destruction that Pescara del Tronto was submitted during the seismic event. The northern area, that includes the road accessing the village, was divided into two different failure levels, D3 and D4. The first level D3 includes buildings with slightly minor damage P1, P2 and P4, and buildings with damage only in the non-structural elements, P3. The level D3/D4 includes the buildings which collapsed partially, P5 and P12. To the southern area was attributed both D4 and D5 as all the buildings partially or fully collapsed, P8, P9, P10 and P13.

Image	Damage level	Damage description
P1	D3	Severe non-structural damage to a RC building, out of plane failure of infills and damage in the beam-column joints
P2	D3	Out of plane mechanism in the connection between roof and walls in a masonry building
P3	D2	Damage to non-structural elements
P4	D3	Out of plane and in plane failures and roof collapse
P5	D4	Partial collapse of a masonry building
P6	D5	Full collapse of a masonry building with RC roof
P7	D2	Sever non-structural damage in a masonry building, out of plane of infills
P8	D5	Full collapse of a masonry building with RC roof
P9	D4/D5	Panoramic view of fully collapsed masonry buildings
P10	D4/D5	Full collapse of a masonry building
P11	D3	Corner detachment below the tie rods
P12	D4	Partial collapse of a brick masonry building
P13	D4/D5	Panoramic view of fully collapsed masonry buildings
P14		Effects of landslides

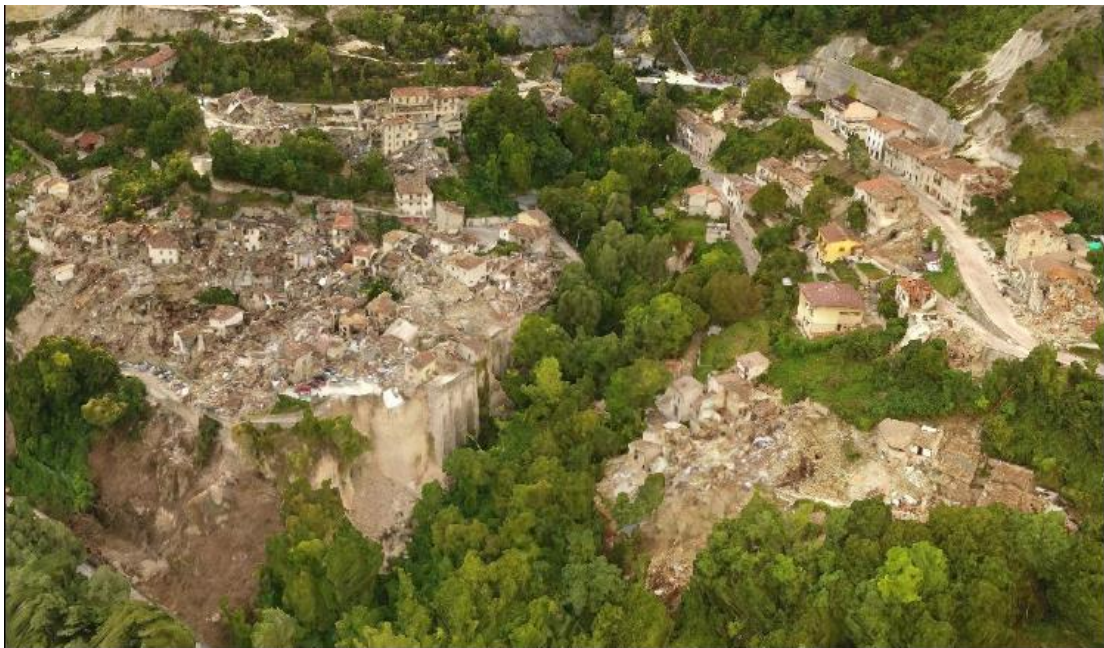
Figure 4.16-3D model from drone flights on the village of Pescara del Tronto

Damage patterns were documented in figure 4.16 in a 3D model of Pescara elaborated by the GEER team. This model clearly shows the various landslides occurred, and in evidence is the main landslide

due to a retaining wall failure. It is also visible the full destruction in the southern area, while the buildings along the road behaved better during the seismic action. As stated previously, the severe damage in Pescara del Tronto was accompanied by large landslides deforming the ground permanently, which caused even more destruction to the village.

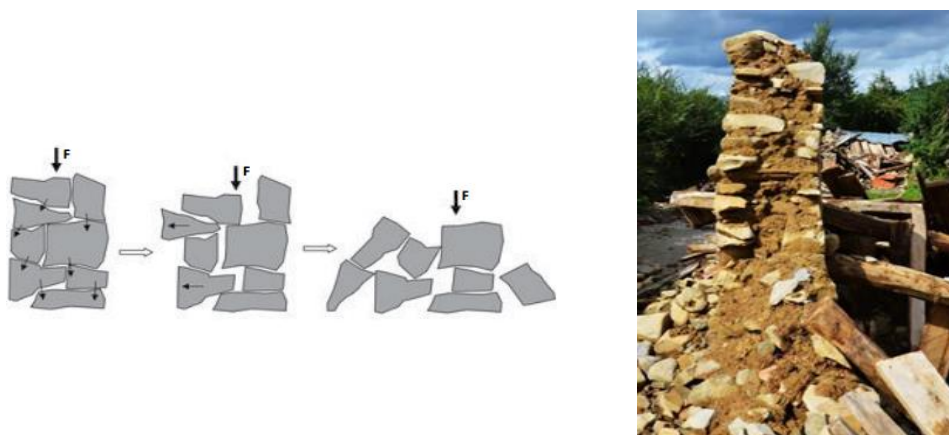
During the seismic action, these irregularly placed stones tend to move out from the wall causing localized damage or even its collapse, in extreme cases, figure 5.2 a) and b). In these figures, it is visible the presence of stone elements of minimum size disconnected from the mortar, which reveals two deficiencies: the low quality of the mortar and the absence of so-called headers, meaning that the leaves are not transversely connected. Figure a), on top of these features, also exhibits round shape river stones whose link with mortar is much weaker comparing to squared shape stones. Figure b) the bad state of maintenance also compromises the rest of the building.

Figure 5.1 -Detail of wall failure caused by irregular stones (Bothara and Hıçyılmaz). On the right, a building collapse due to its poor quality masonry, which included soil mortar

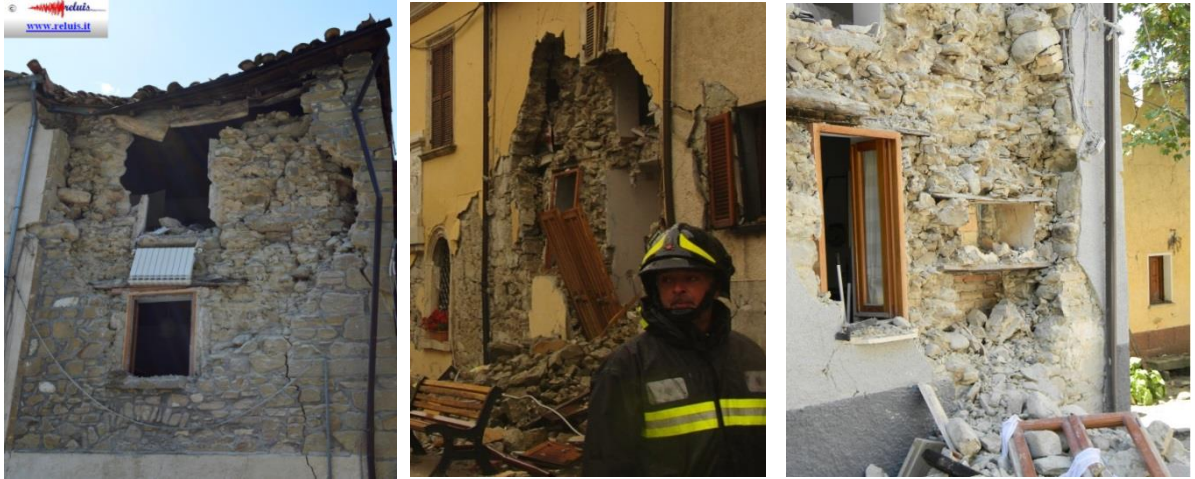
The following figure 5.4 represents cases of external leaf overturning in a double leaf masonry wall due to the poor quality of masonry and the absence of the so-called headers.

Figure 5.4 -External leaf overturning in Pescara del Tronto and Arquata del Tronto

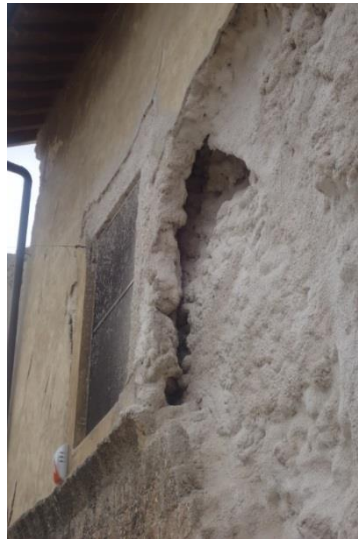
Another type of disconnection between leaves happened in one church in Norcia where the type of masonry was a three-leaf wall, with limestone inside and regular stone on the outside, section 3.1.1.3. In the figure 5.5 it seems to have occurred saline efflorescence which weakened the masonry wall and facilitated its delamination.

Figure 5.5-Saline efflorescence
in one church in Norcia

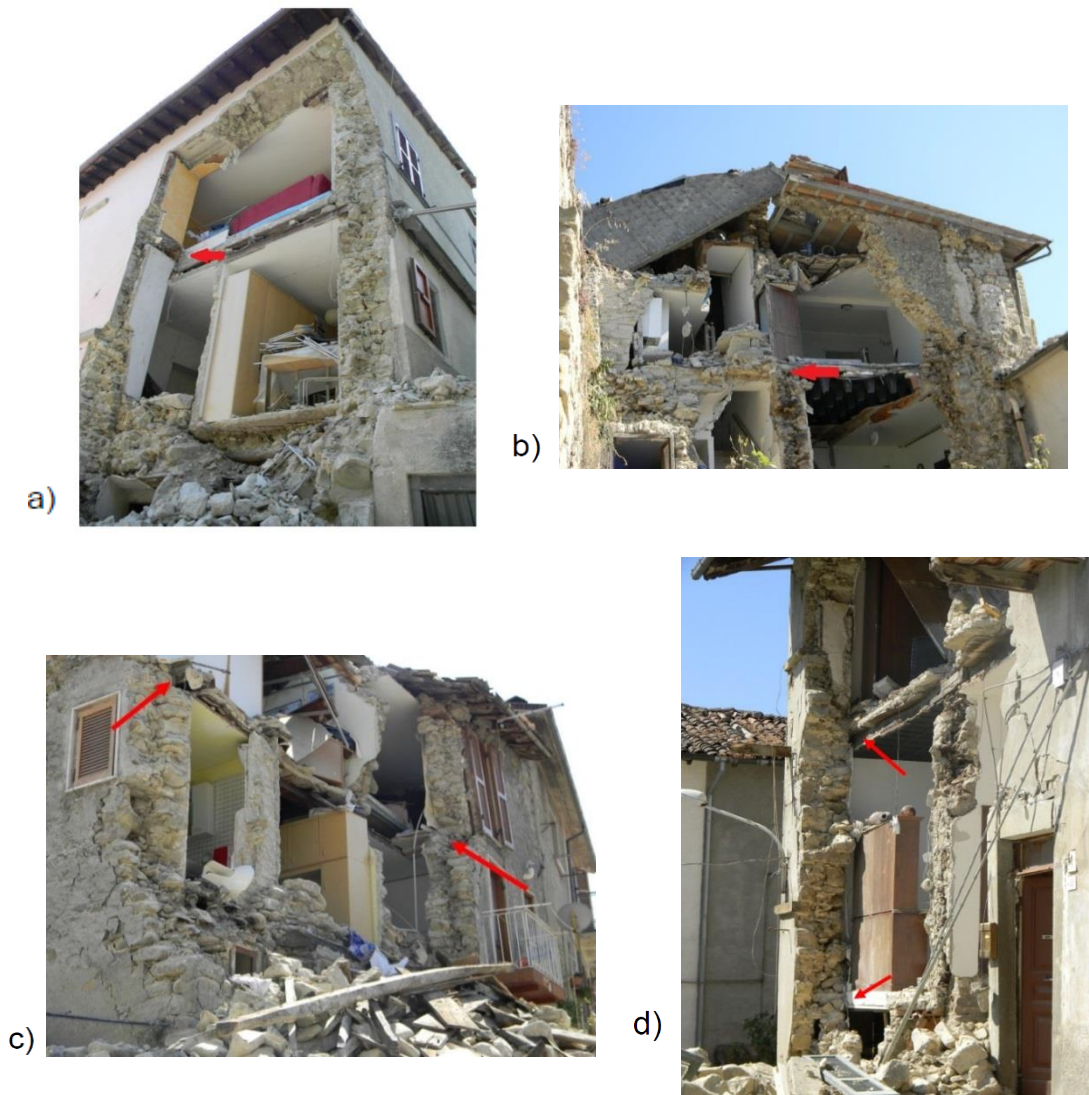
In the figure 5.7 is well visible the absent connection between the floors and the walls (pointed by the red arrows) causing the full overturning of the façades. In addition, the excessive thickness of masonry walls, result in significant inertial forces that facilitates the collapse of façades by simple or partial overturning. The bad quality of masonry described in section 3.1.1.3 is visible in all pictures. In figure a) the only good connection is the one between roof and walls.

Figure 5.7-Overturning of the front façades due to lack of connections between walls and slabs

In order to permit a reasonable behaviour, is necessary to improve the connections between horizontal (floors and roof) and vertical elements (masonry walls). Connections between structural elements are a key aspect for effective seismic resistant construction. Ensuring the ‘box behaviour’ of a building, where the horizontal forces are absorbed by walls in the same plane, is the most effective measure against earthquakes, section 3.1. When the walls are not connected at the intersections, each wall is expected to vibrate on its own when subjected to earthquake ground motion, figure 5.6. In this situation, the walls perpendicular to the direction of the shaking are going to experience out of plane vibrations and possibly collapse when connection between roof and walls is not adequate. Walls parallel to the direction of the shaking, shear walls, are also susceptible to damage. When the walls are well connected, by a rigid roof, and/or a horizontal ring beam at the slabs, the building acts as a monolithic box which is the satisfactory seismic performance, as aforementioned, in the section 3.1.

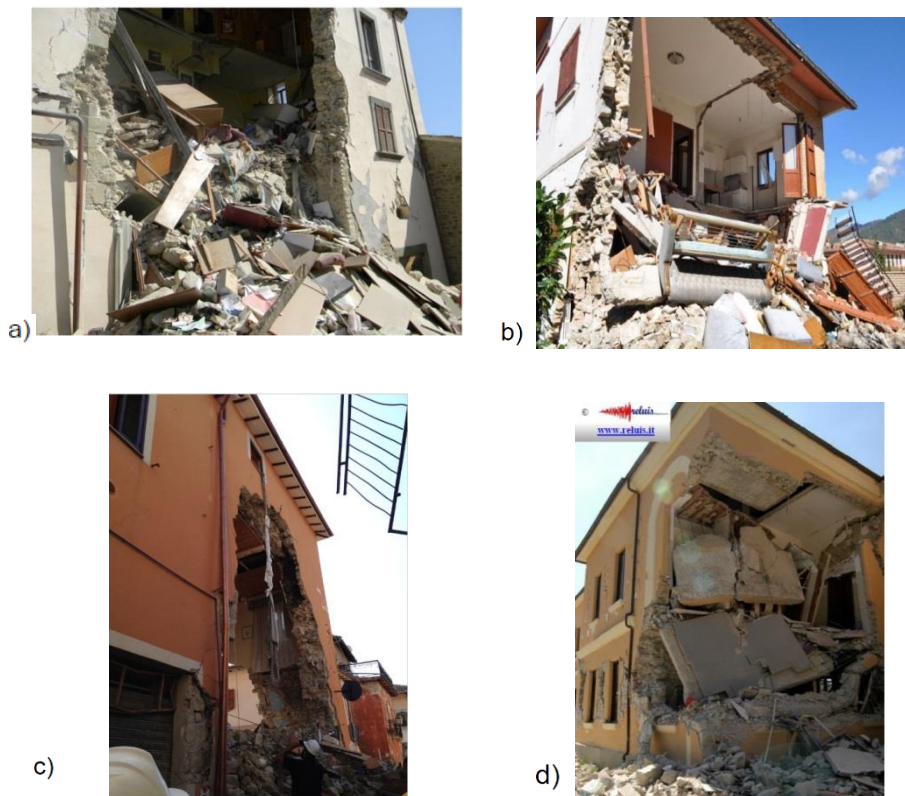
Floors collapse due to failure of connections between the floors and the walls (figure 5.8), causing the overturning of the perpendicular wall and loss of support of the floors beams. Once again, the poor masonry in the pictures is a constant. In most cases, bonds between the floors beams and the walls are not correctly done and under the seismic action these defects come to the surface as slippage between the beams and the wall, figure 5.9. In figure d) the floors are still supported by the walls opposite to the ones which collapsed.

Figure 5.9-Collapse of floors due to slippage of the beams

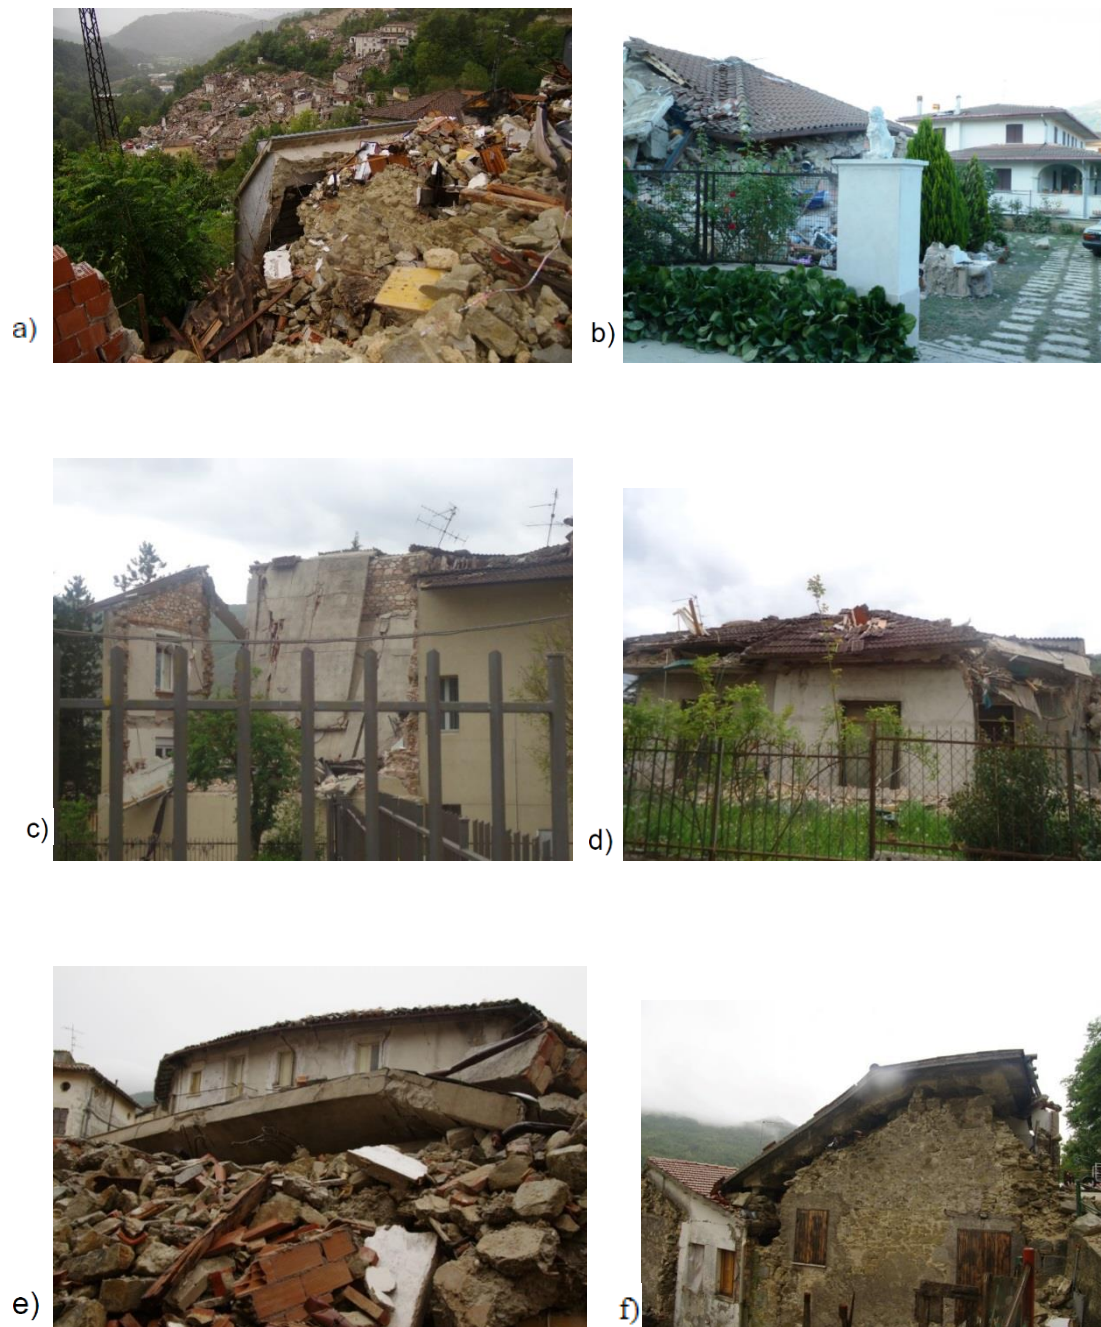
The following pictures are all examples of this type of failure. In some pictures, the walls totally collapsed while in other cases the walls remained standing, figure 5.11. The example of the figure f), illustrates the case where the concrete roof hammered the masonry walls leading to the collapse of the upper floor.

Figure 5.11 -Collapses due to heavy reinforced concrete roofs

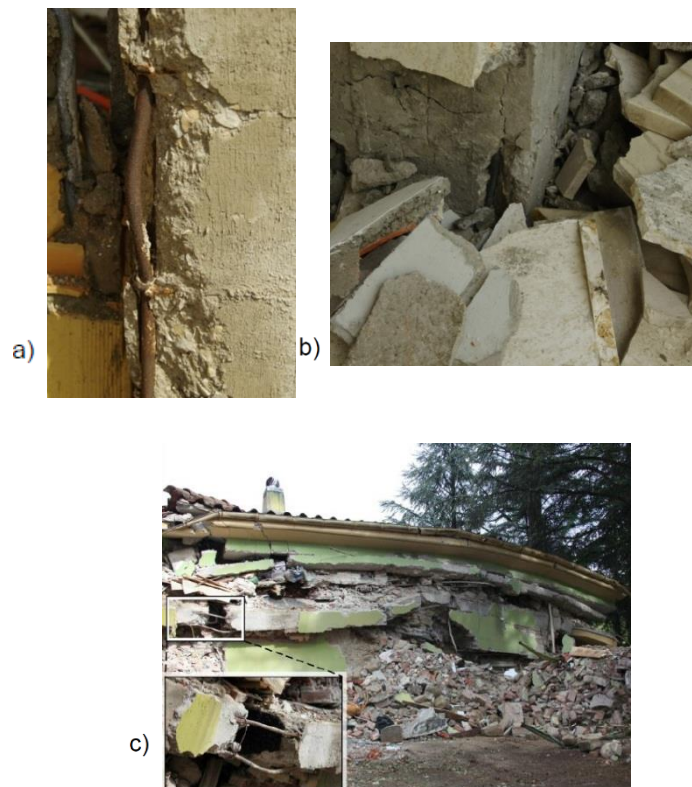
Both columns in figure present “smooth bars” which prevent a good interlocking between the reinforcing bars and the surrounding concrete and facilitated the expulsion of the concrete, section 3.2.4. Also, the excessive spacing of stirrups prevented a good confinement in the columns, leading to the buckling of the transverse reinforcement, figure a).

Figure 5.15 -Wrong type of reinforcement in the columns, Pescara del Tronto. In c) is shown the detail of the smooth bars in a reinforced building collapsed

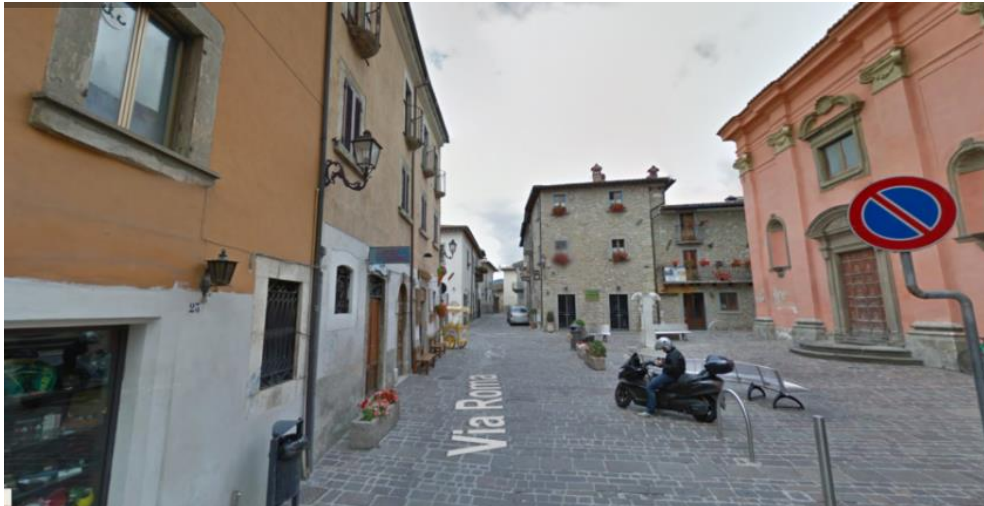
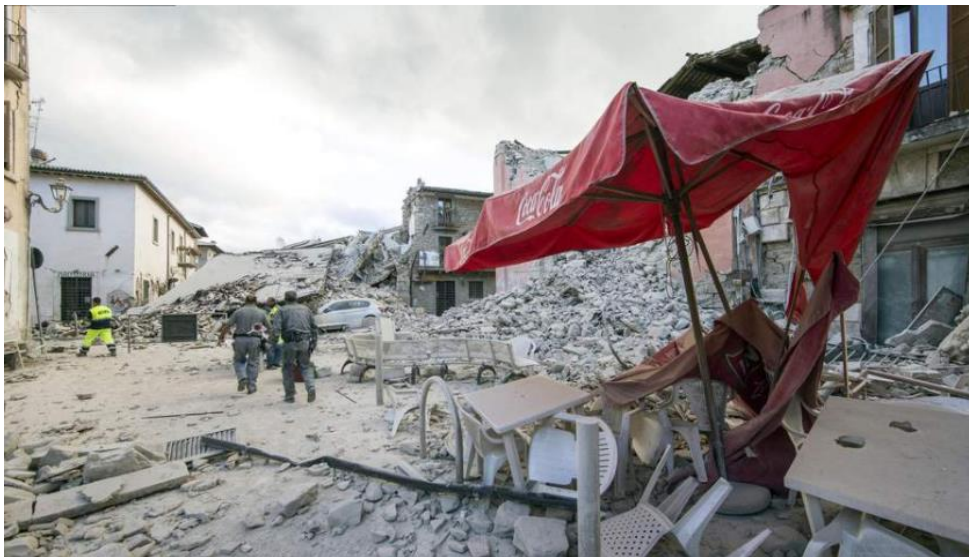
a)

One square totally destroyed in the southeast, the most affected area of Amatrice.

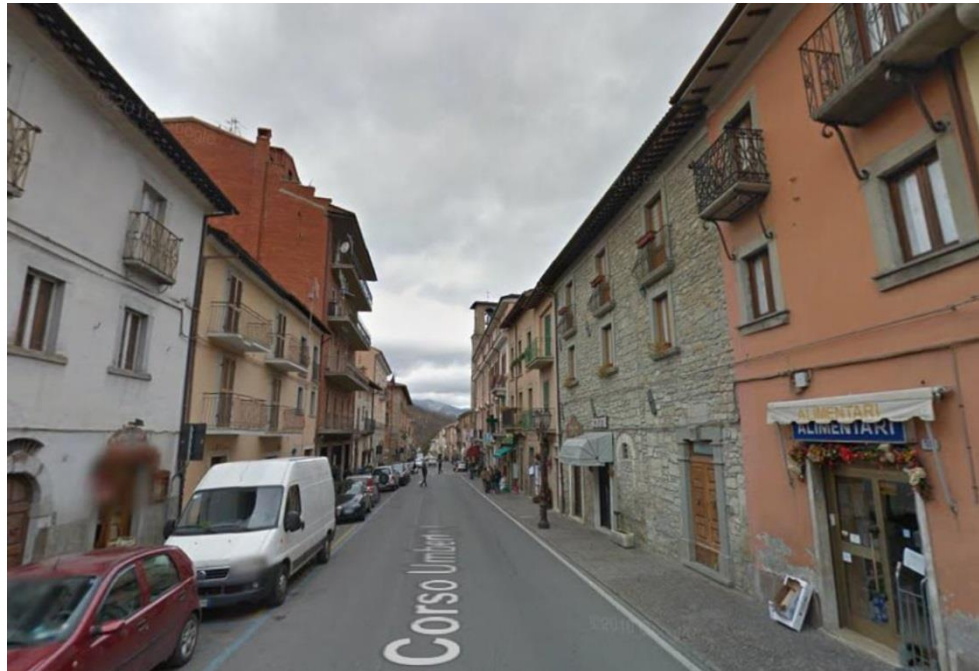
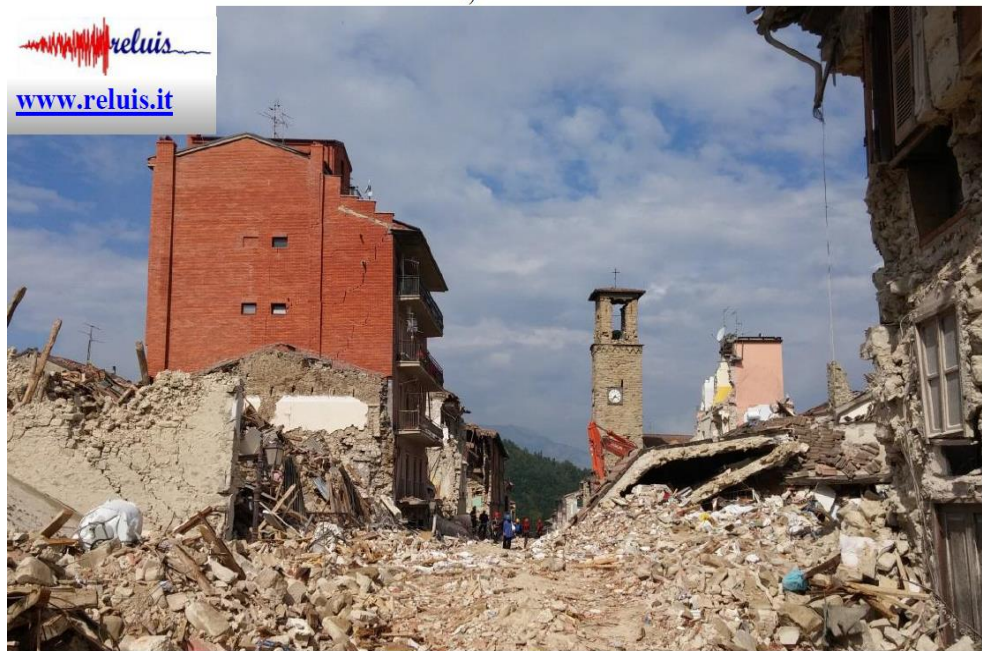
b)

Main street in Amatrice, Corso Umberto I, ruined after the earthquake.

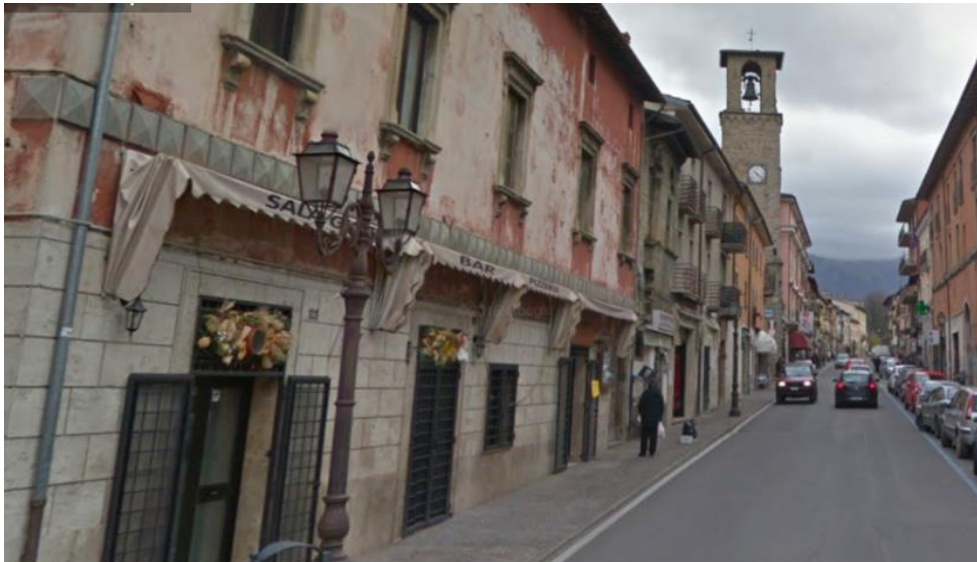
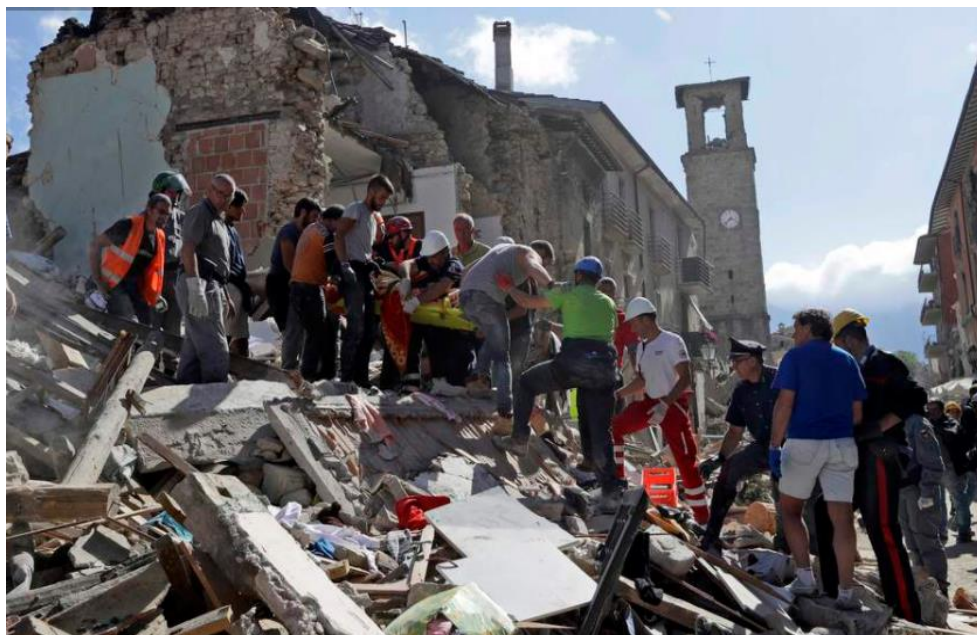
c)

Row of buildings devastated in the red zone.

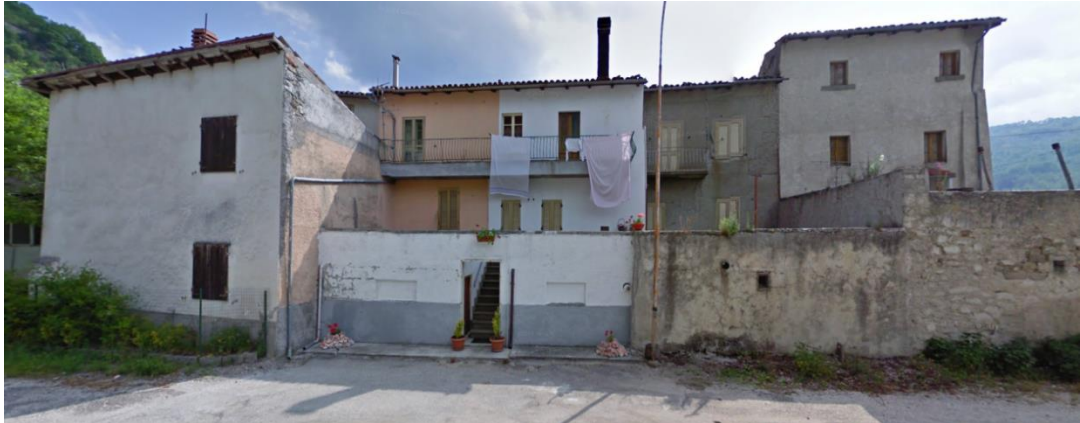
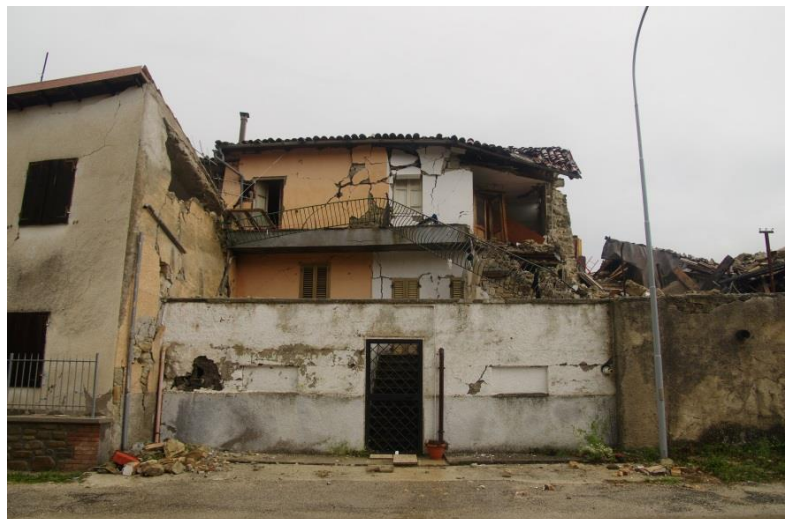
a)

Global collapse of two buildings on the right, and partial collapse of the façade of the white building. The building on the left suffered partial overturning of the upper part of the wall. These two-storey buildings coincide with the typology of structures more damaged within the affected areas: low masonry buildings, section 2.6.

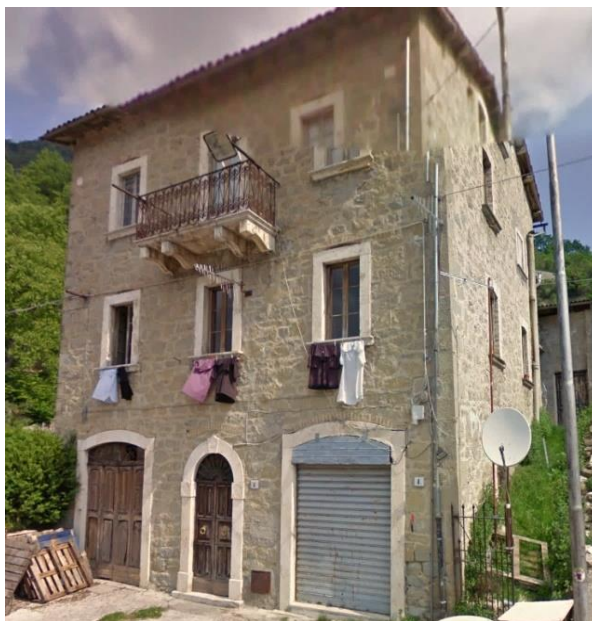
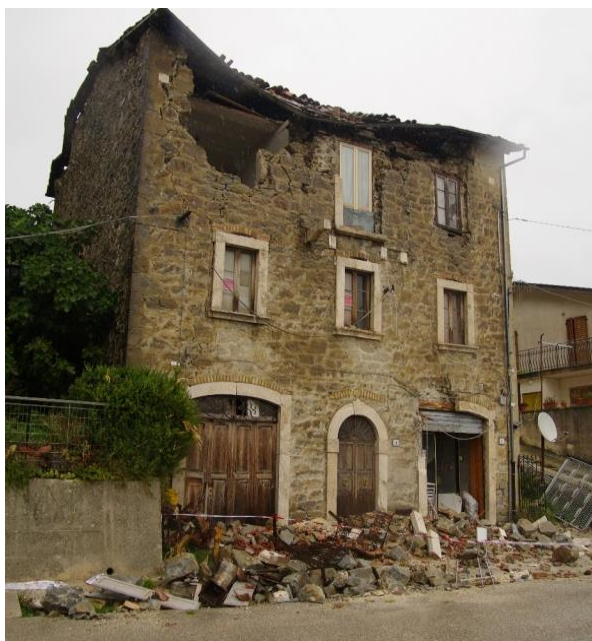
b)

Partial collapse of the upper floor, close to the connection with the roof. Possibly the thrusting roof activated the out of plane mechanism. Evident poor quality of the masonry.

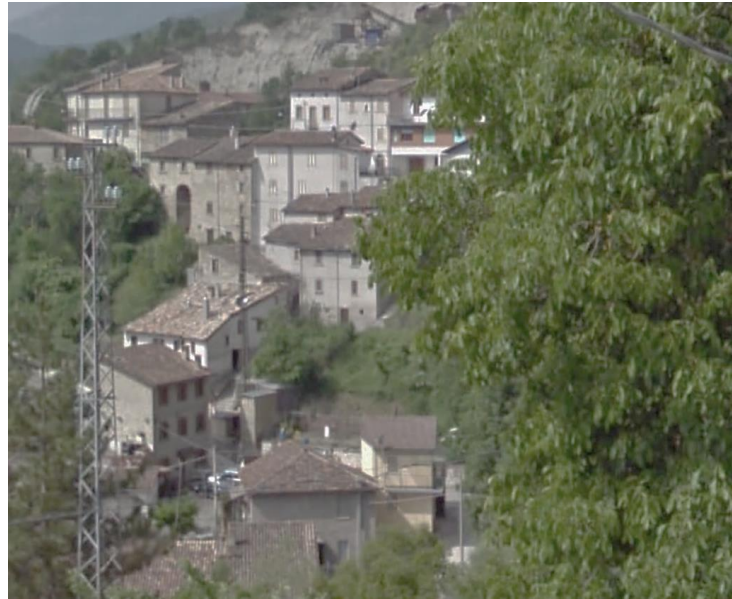
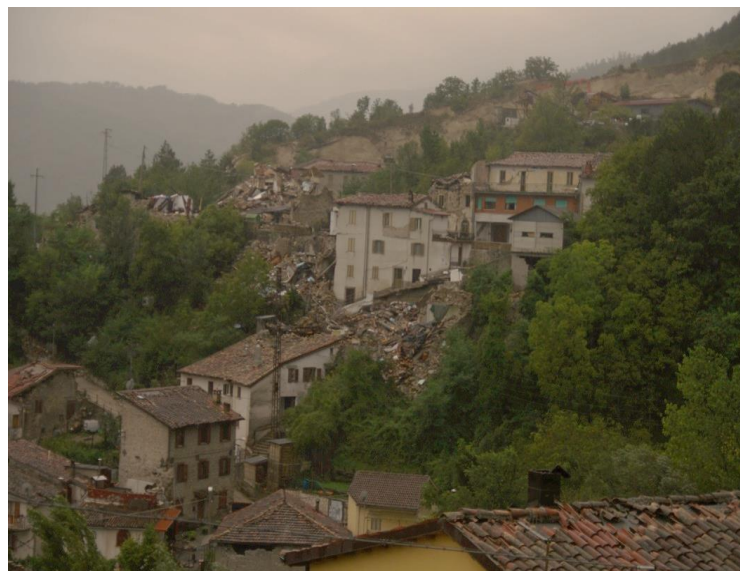
h)

Pescara del Tronto was all but destroyed after the devastating earthquake.

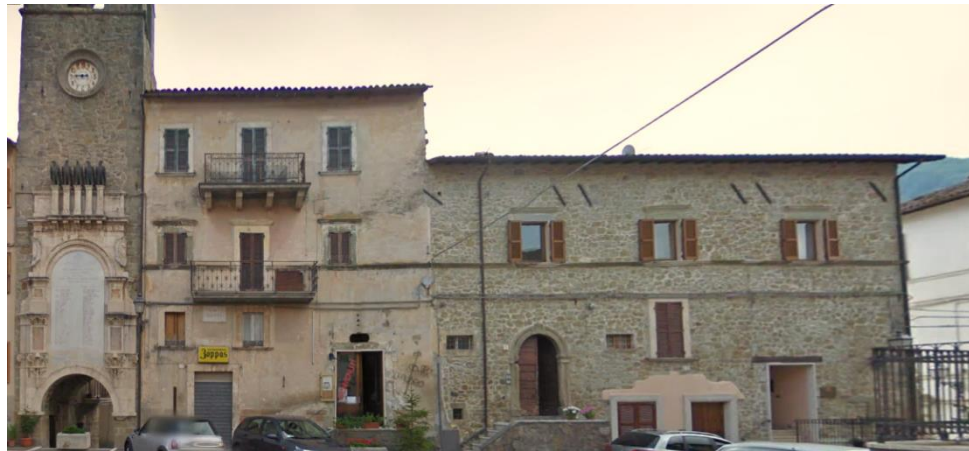
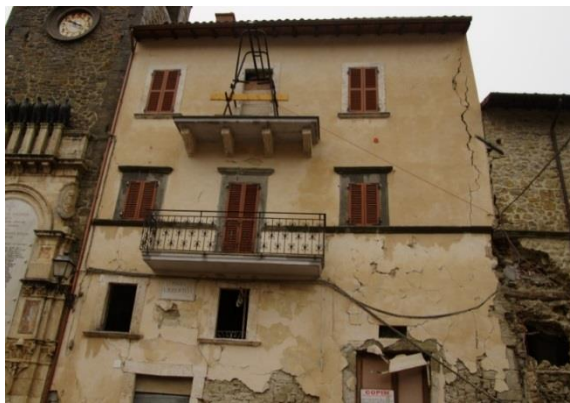
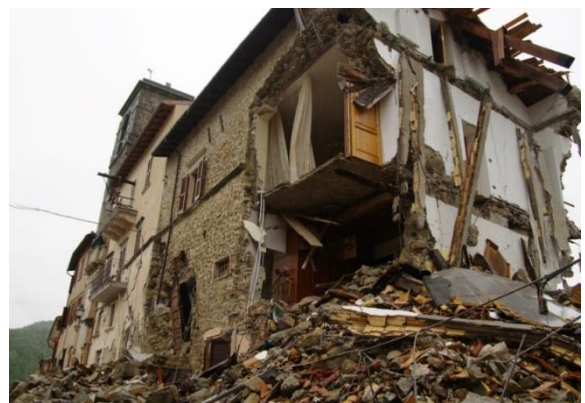
d)

The two adjacent buildings showed completely different behaviours. The one on the right behaved well only exhibiting in plane cracking with detachment of material in the ground floor. The vertical crack along the intersection (type 7 from AeDES classification) with the adjacent building, seems a sign of an incipient out of plane mechanism, simple overturning. The building on the left partially collapsed due to the interaction between reinforced concrete slabs and poor quality of masonry.

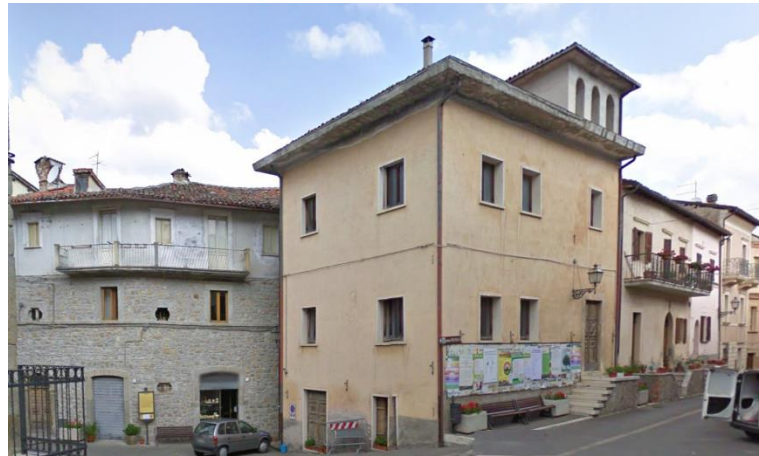
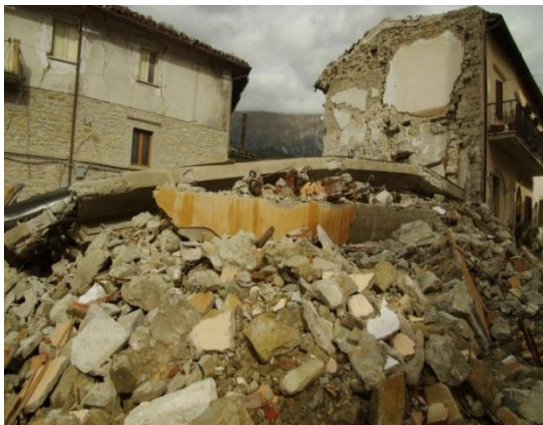
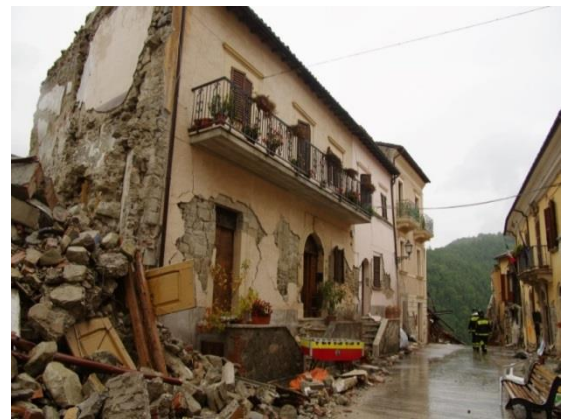
f)

Global collapse of a masonry building with concrete roof in the main square of Arquata del Tronto. The adjacent buildings, the pink one, exhibits diagonal shear cracking in the pier panel (type 3 from AeDES classification).

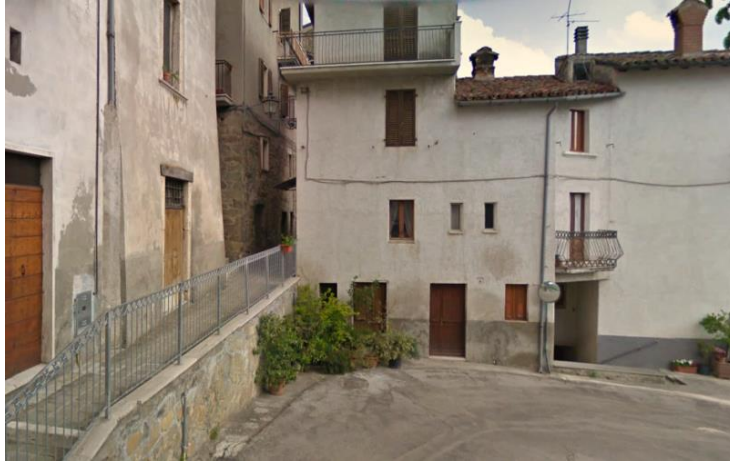
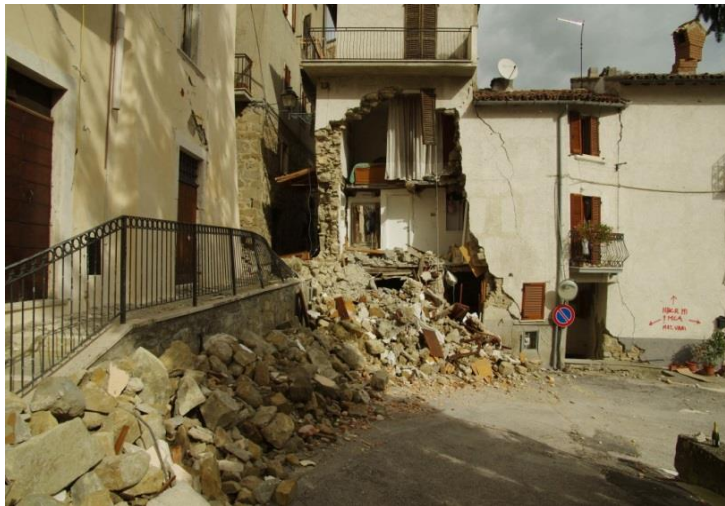
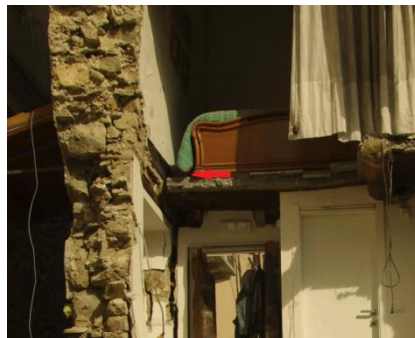
g)

Overturning of the front façade involving three floors due to interaction between two buildings with different stiffness. Also, defective connections between diaphragm and vertical elements in the intermediate floors may have caused the vertical bending mechanism (red arrow in the detail picture).

Pounding is also evident between the lower building and its adjacent. The chimney suffered rotation and sliding, figure 5.19.

With a closer look, it is detectable that the two small windows in the before picture were closed and behaved well during the earthquake event, meaning that its closure was correctly conceived (the original opening must be fully filled to avoid its disintegration under dynamic loads)
